This 2000 Buick Regal was involved in a serious front end collision with a pole. The intrusion (depth of damage) on the Regal is considerable.

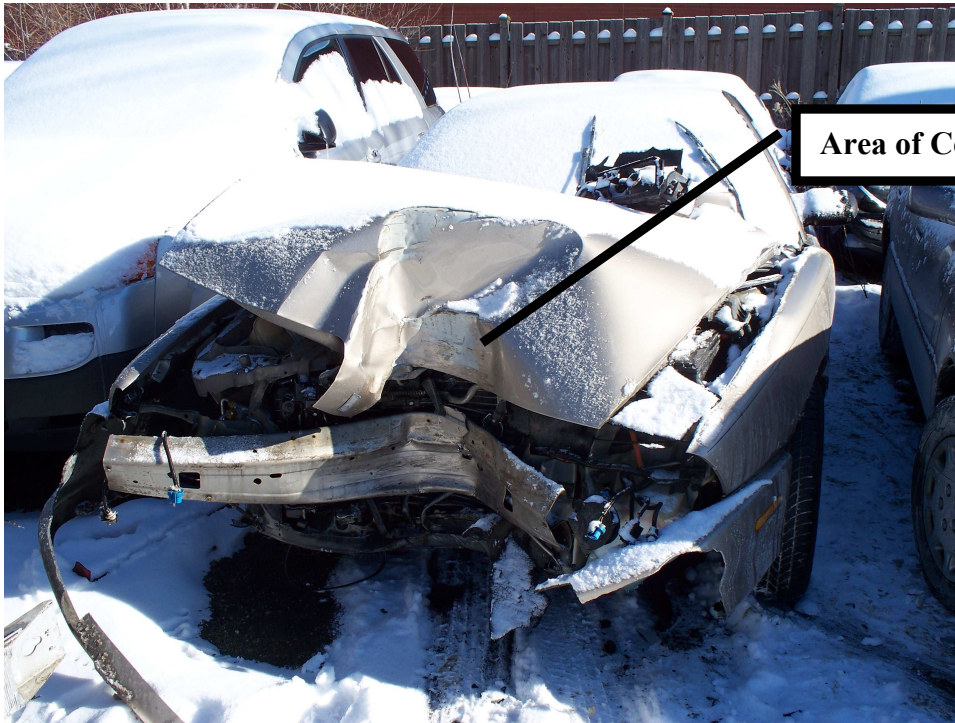
Area of Contact Damage with Pole

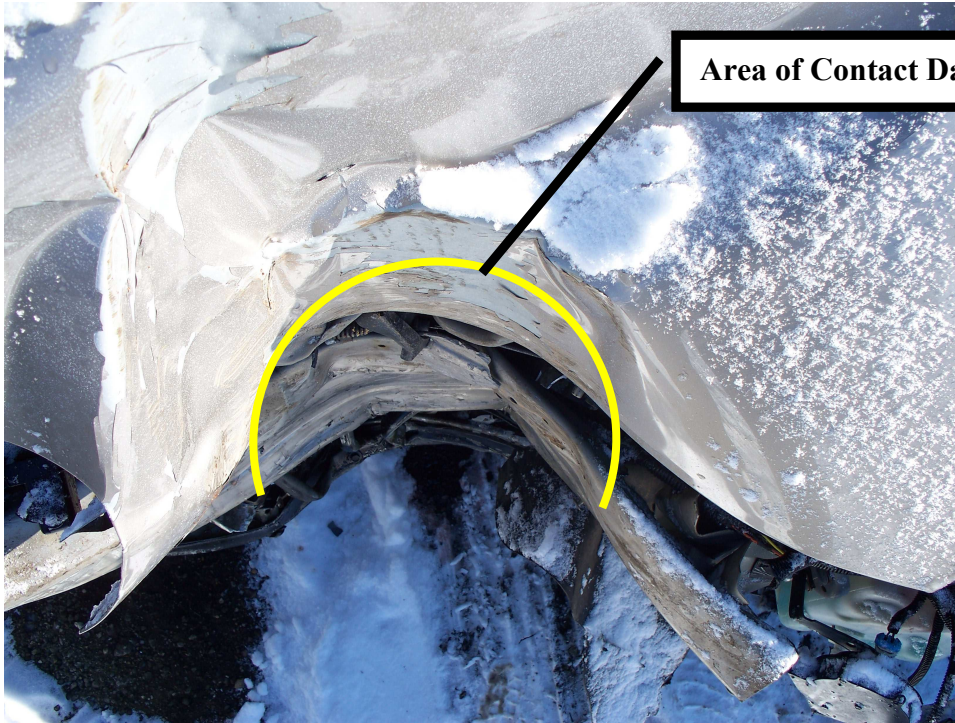
Area of Contact Damage with Pole

Notice how the area that directly contacted the pole was rounded and pushed inward. Only a collision with a hard cylindrical object can cause this type of damage.
