This 1992 Chevy Blazer was involved in a serious front end collision with a pole. The intrusion (depth of damage) on the Blazer is considerable.

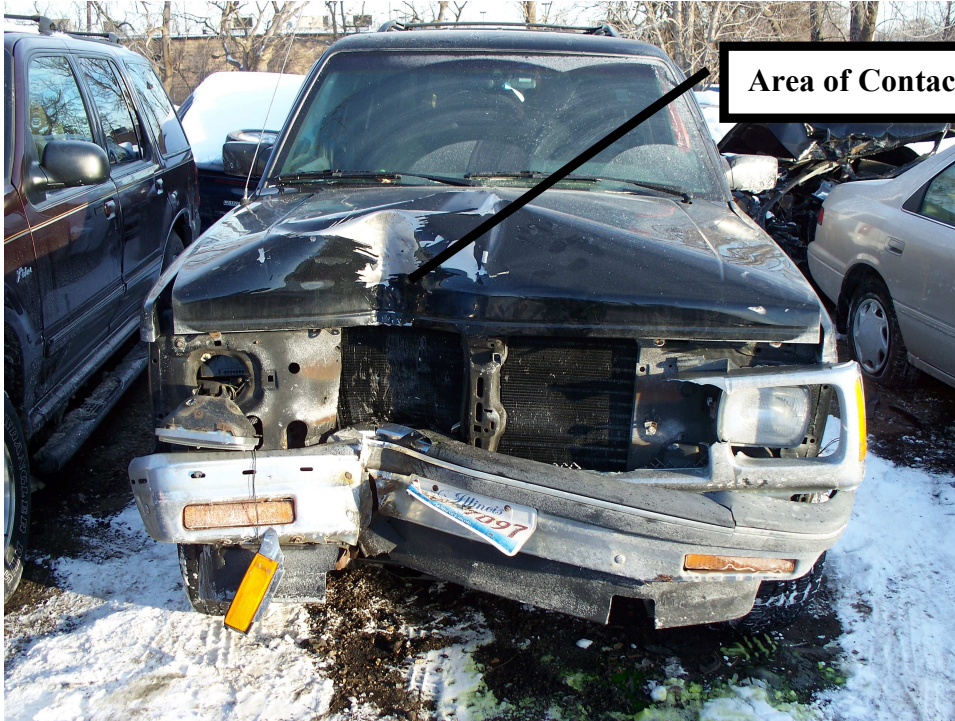
Area of Contact Damage with Pole

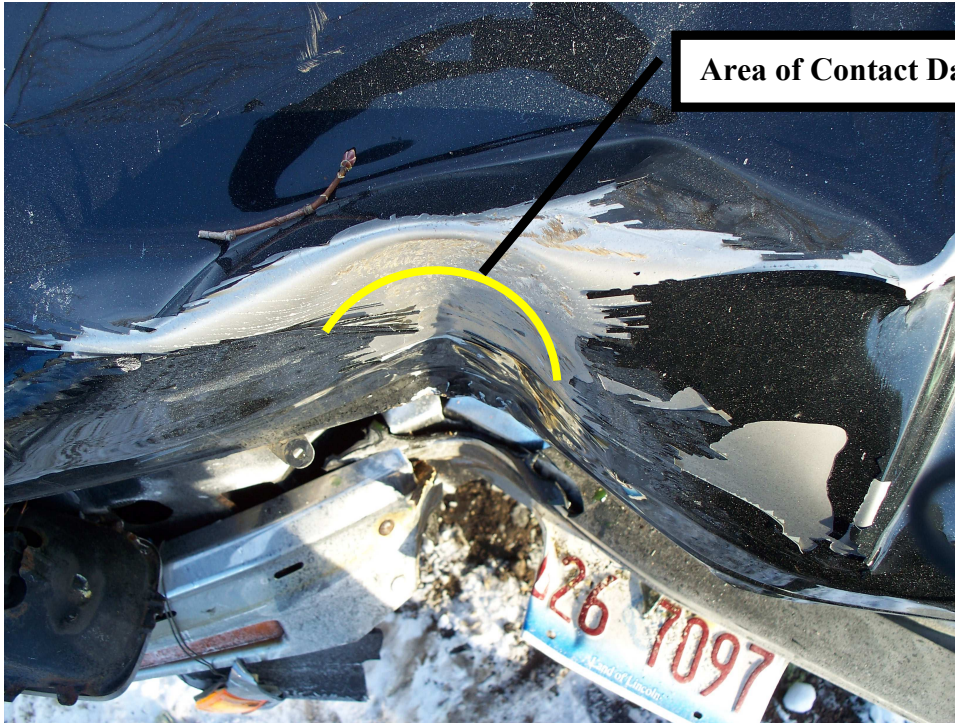
Area of Contact Damage with Pole

Notice how the area that directly contacted the pole was rounded and pushed inward. Only a collision with a hard cylindrical object can cause this type of damage.
